## Philips Respironics update related to Trilogy 100/200 repairs

On June 14, 2021, Philips' subsidiary Philips Respironics, initiated a voluntary [recall notification/field safety notice](#) to address potential health risks related to the polyester-based polyurethane (PE-PUR) sound abatement foam in specific CPAP, BiPAP and mechanical ventilator devices. Philips Respironics expects to repair or replace approximately 5.5 million devices globally, and approximately 95% of the registered affected devices are CPAP and BiPAP sleep apnea devices. The repair and replacement program involves the replacement of the PE-PUR sound abatement foam by silicone foam. The repair and replacement of CPAP and BiPAP sleep apnea devices is well underway globally.

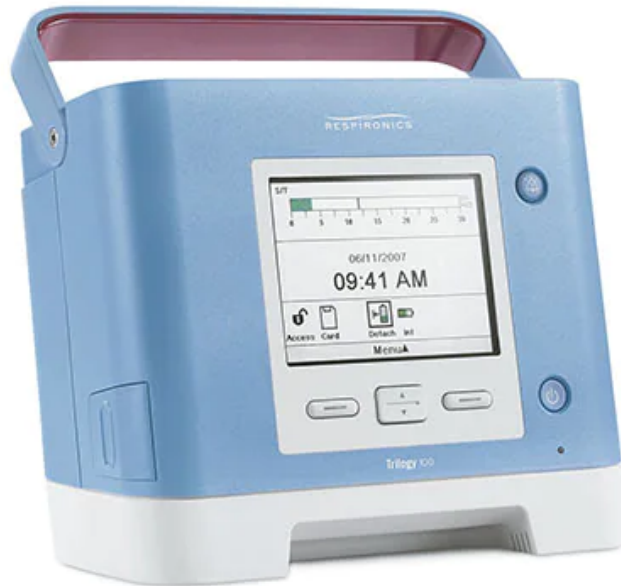
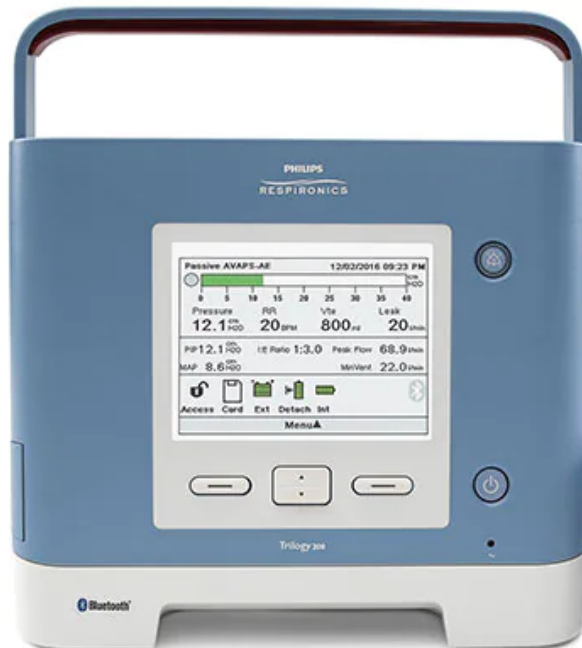
*Philips Respironics Trilogy 100 and 200 devices*

- *Silicone Foam Separation* - Post market surveillance data received from Japan and the US indicate that silicone sound abatement foam installed in reworked Trilogy 100/200 devices may potentially separate from the plastic backing to which it is adhered. Separation of the foam could impact the performance of the device by potentially blocking the air inlet and thus lowering the inspiratory pressure. If the air pressure is significantly impacted, the device could issue a ventilator alarm, such as the *Low Inspiratory Pressure* alarm. As of November 1, 2022, the observed occurrence rate of reportable events is less than 0.015 percent of corrected Trilogy 100 devices. Based on information available to date, the root cause is associated with an assembly step in inserting the silicone foam.
